Development of Biocolonization Resistant Mortars: Preliminary Results

F. Henriques¹, A. E. Charola², V. Moreira Rato¹ and P. Faria Rodrigues¹

¹Universidade Nova de Lisboa, Portugal

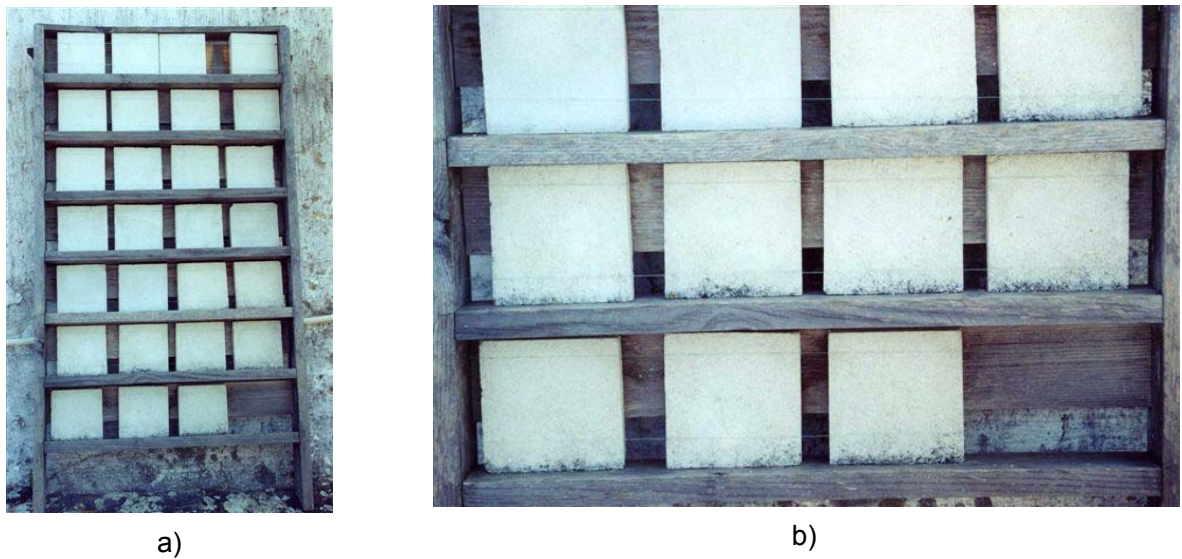
Figure 1: Samples photographed in 2001 (a) Original disposition of the samples on the rack after two and a half year exposure. (b) Detail of the samples in the lower shelves which developed some biocolonization.

The samples were exposed at roof level in Sintra for over 8 years, from January 1999 to July 2007. They were placed vertically on a rack which protects them from water running down their surface (see Figure 1 for a photograph of the setup).

By 2001, after two and a half year exposure, it was seen that the samples located in the two bottom rows had started to develop biological colonization, as shown in Figure 1a and, in detail, in Figure 1b. Biocolonization was found to develop from the bottom up of the sample presumably because the wooden shelves kept moisture longer.

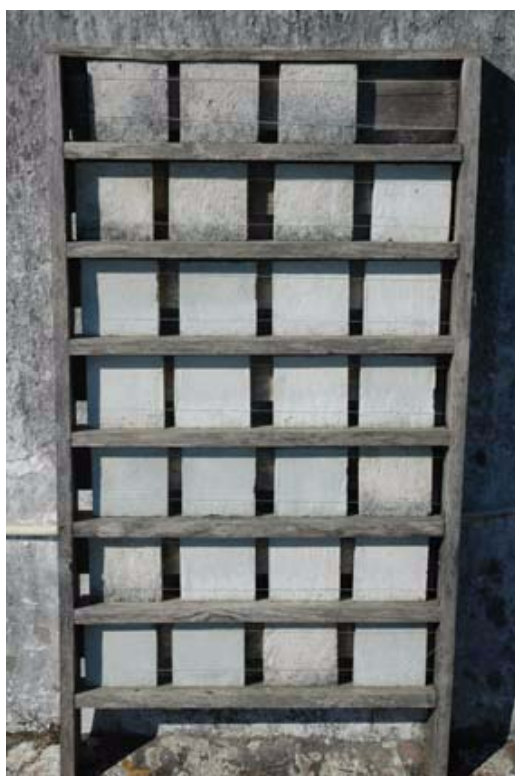
Two years later (July 2004) some signs of biocolonization appeared, particularly for the samples in the upper shelves and the three controls as shown in Figure 2.

Figure 2: Photograph of the rack with the samples exposed after four and a half years (January 1999-July 2004). Note the darker areas of biological colonization for the samples in the top two shelves.

The samples that showed higher biocolonization were primarily those that had originally developed it, i.e., the controls (C), those with the single wires, thick (Ig) or thin (If) and those with the 5 thin wires (I5f), even though they had been switched around on the rack. Interestingly, one of these samples (If-1) developed a fruticose lignicole yellow lichen in the lower left corner, presumably because the sample was resting on a wooden rack.

Other samples not readily visible in the above photograph but which on direct observation showed colonization were the three samples with fibres at the lower and medium concentration (F1 and F2) as well as one of the powder samples at the lowest concentration (P1-1). One of these samples (F2-1) also grew a small yellow lichen.

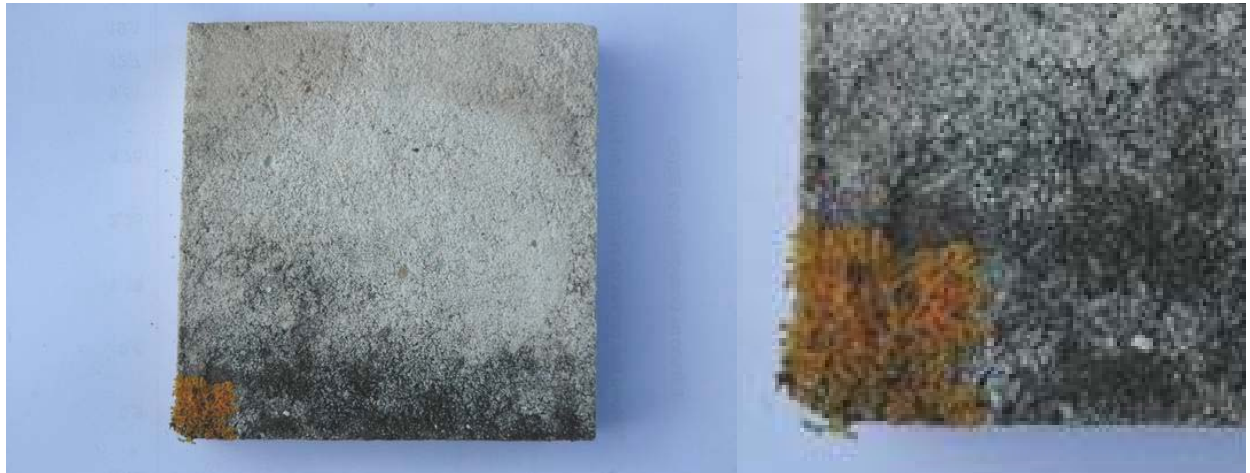
Figure 3: Sample IF1 in 2007 showing the growing fruticose lignicole lichen that had already developed by 2004 and detail of the lichen.

To be noted was the increase in size of the yellow lichen of sample If-1, as shown in Figure 3, while that of sample F2-1 had practically disappeared.

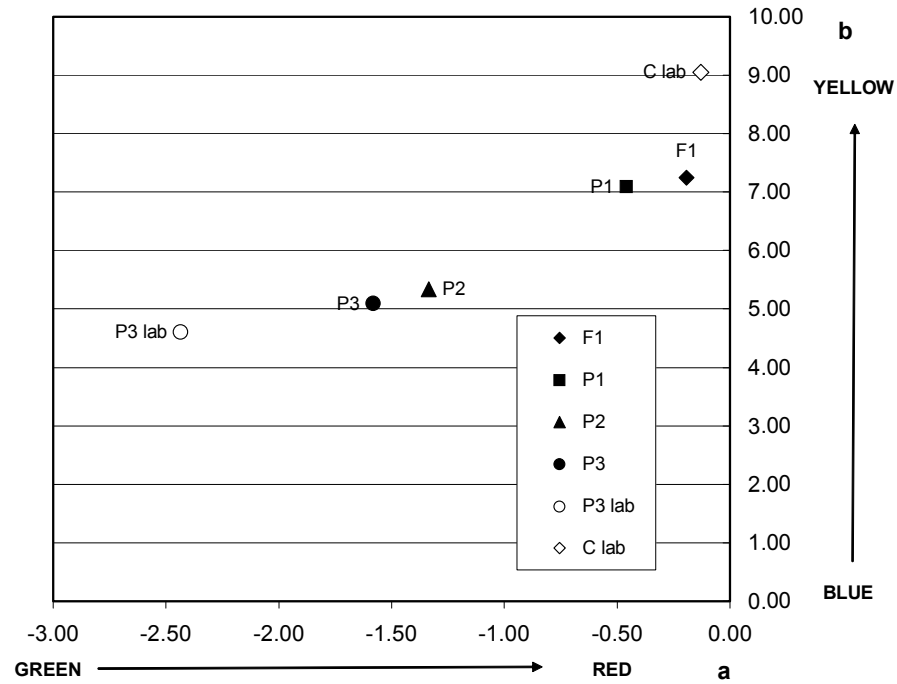
Figure 4: Plot of the average a^* and b^* values for samples containing different amounts of copper. The samples with a higher amount of copper show an increase towards the blue-green colour.

It can be seen that the L* values, which measure lightness on a scale from 0 (black) to 100 (white) are fairly close, reflecting the greyish colour of the mortars. However, there are changes for both the a* and the b* values which measure the changes from red (+) to green (-), and yellow (+) to blue (-). The plot of these data is shown in Figure 4 where it can be seen that as the copper content increases there is a change towards the blue-green colour field.

Interestingly, the bluish-green hue of the copper containing mortar decreases upon weathering which could be attributed to an increase in roughness and therefore increased light scattering and as reflected by the decrease of the L* value from around 84 to 80.

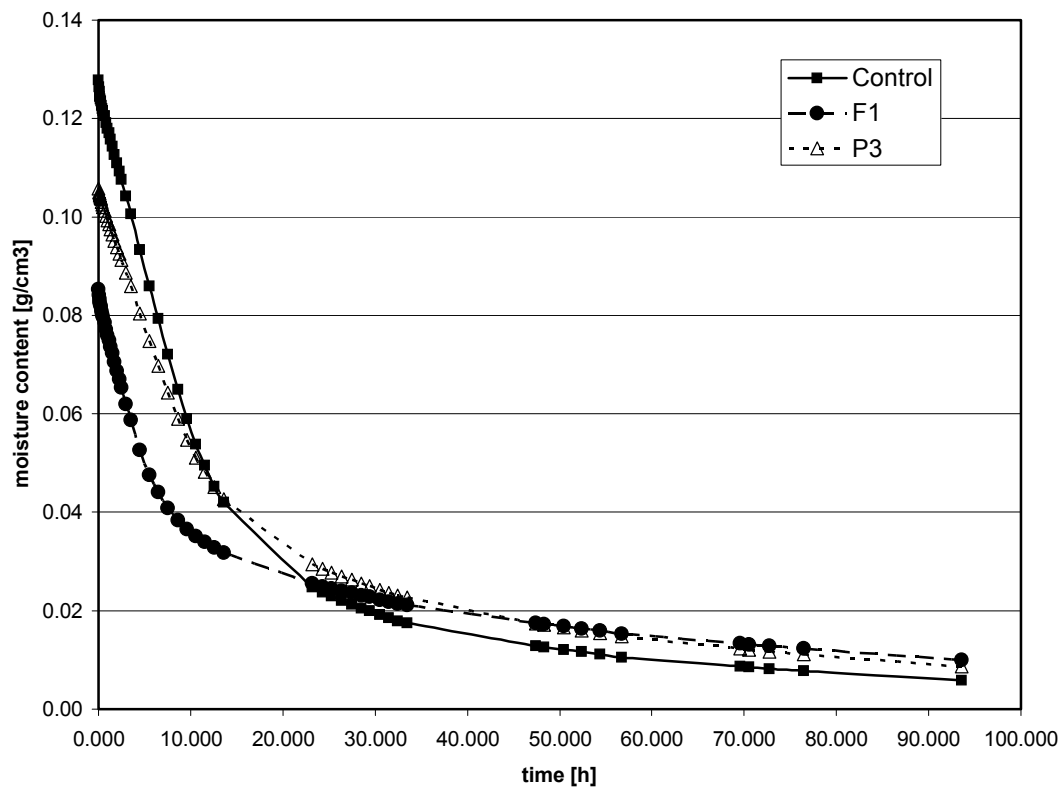
Figure 5: Average drying curves for the exposed samples. The control samples had the highest biocolonization of these samples, followed by the F1 samples, while the P3 showed no apparent biocolonization.

and P3, cannot be compared with the square samples that were exposed, C, F1 and P3, because of their difference in shape. Particularly these exposed samples gave the most interesting drying curves, as shown in Figure 5.

It can be seen that both samples with biocolonization, C and F1, have a faster initial drying rate. This drying rate corresponds to that occurring by evaporation from the surface and corresponds to a capillary water transport in the interior of the sample. For the unexposed samples, the control also has a

However, the final drying rate, which corresponds to a pure water vapour diffusion mechanism, is slightly faster for the P3 sample, and this is also the case for the unexposed samples, probably because these samples still hold more water than the control. Interestingly, the F1 sample is the one that has the highest moisture content by the time the final drying rate is achieved.
